# Case Study of a Clock Spring® Composite Sleeve Application as a Permanent Pipeline Repair in Indonesia

Dimas Satya Lesmana S.T.<sup>1</sup>

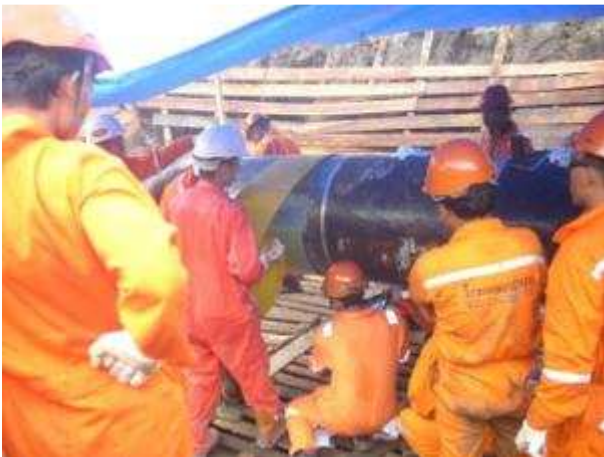
During routine excavation the excavator accidentally hit a 28" main gas transmission line situated at in the middle of the Perawang jungle in Pekanbaru – Riau, Indonesia.

The excavator had "caught" the pipeline causing a significant mechanical defect with 3 meters of the pipeline being damaged. As the pipeline is the main supply to a local power station and also to Singapore, it was critical the pipeline remained in operation, it was mid Summer with temperatures in excess of 39 °C and a peak period for electricity supply.

Figure 2. Installation of repair sleeves on the 28" gas line

The Clock Spring® repairs for the 28 inch API 5L X65 were installed within 3 days on site without interrupting the pipeline operations.

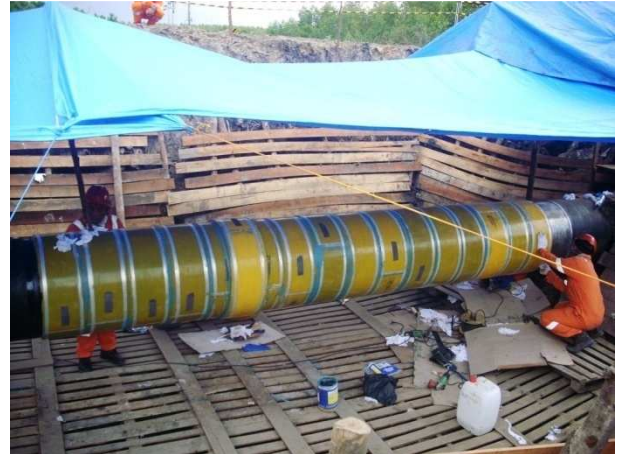
Figure 3. Installation of repair sleeves on the 28" gas line

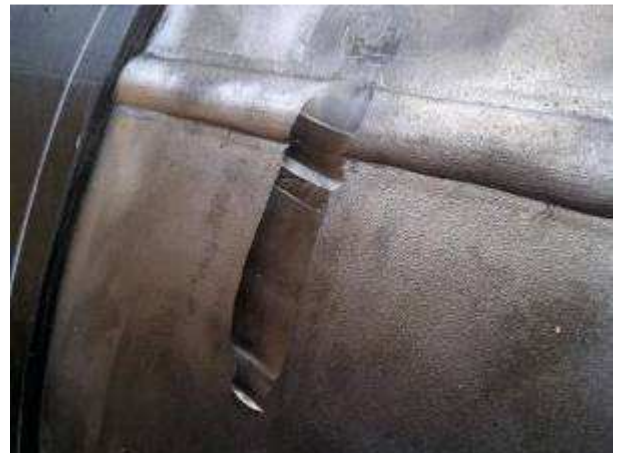
An external defect suspected due to mechanical damage by backhoe loader during pipeline installation was found after ILI inspection for a main 32" gas transmission line supplying gas from Sumatera to Java.

Figure 4. Defect in the 32" pipeline also affecting the seam weld

Following excavation and manual surface preparation in accordance to industry standard guidelines a composite repair sleeve was applied to reinforce the damaged area.

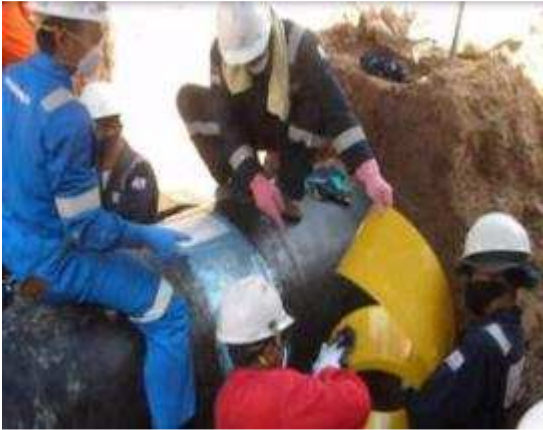
Figure 5. Installation of the 32" seam sleeve

The repair was completed under the supervision of a Clock Spring® installer within 1 day.

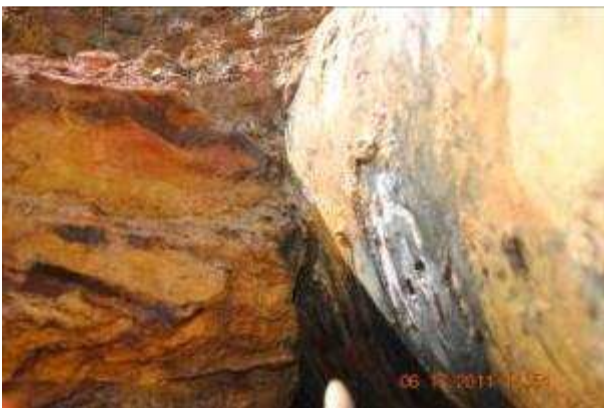
An external defect suspected due to alkaline soil erosion caused a significant mechanical and corrosion damage to the 28" main high pressure gas transmission pipeline supplying gas to the Duri field in Riau.

Figure 6. The alkaline soil erosion type defect

For this repair 4 corrosion sleeves were needed and the repair was completed under the supervision of a trained and qualified Supervisor within 1 day.

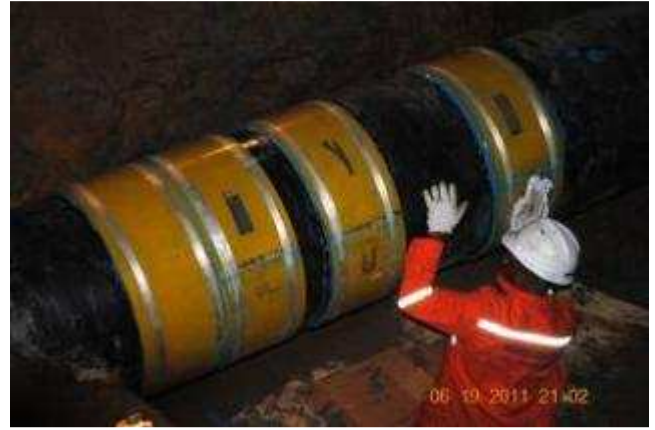
Figure 7. Completed 28" repair sleeve installation

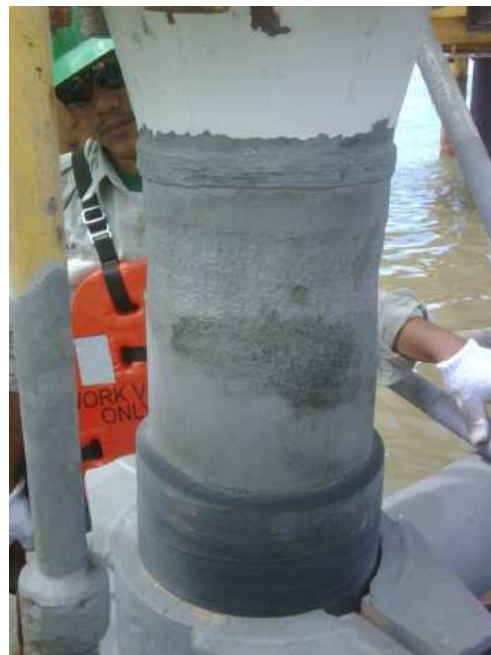
An external defect due to corrosion under insulation (CUI) and hot atmospheric conditions (+80 C) was identified on a high pressure and high temperature riser in Mahakam Delta, East Kalimantan.

Figure 8. Sample of CUI defect

Following surface preparation by sand blasting, a high temperature repair sleeve was applied to reinforce the weak area.

The installation was completed by a two (2) mancrew under the supervision of a trained supervisor within 1 day with no need to shut in the riser and no hot work or specialised installation equipment.

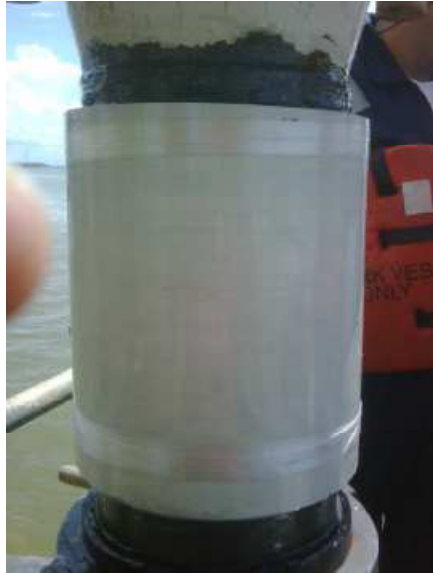
Figure 9. Completed high temperature composite sleeve repair

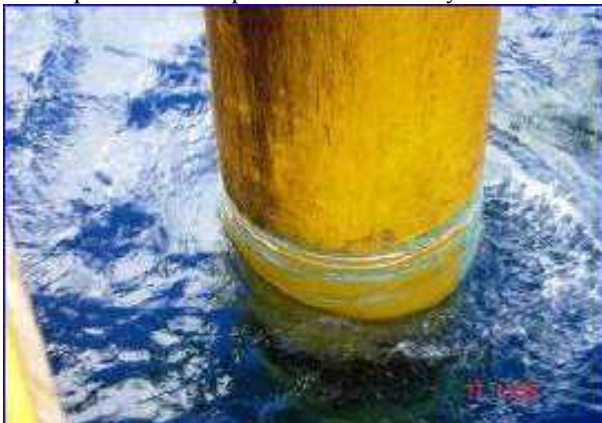
External corrosion due to harsh sea environment caused a leak on a 42" skim pile at the splash zone area. The platform is in the Natuna Block.

Figure 10. Completed 42" Skim Pile repair

Following grit blasting and surface preparation in accordance to industry standard guidelines a Snap Wrap full cured laminate repair was applied to seal the leak and reinforce the general corrosion area.

The repair was completed within 1 day.

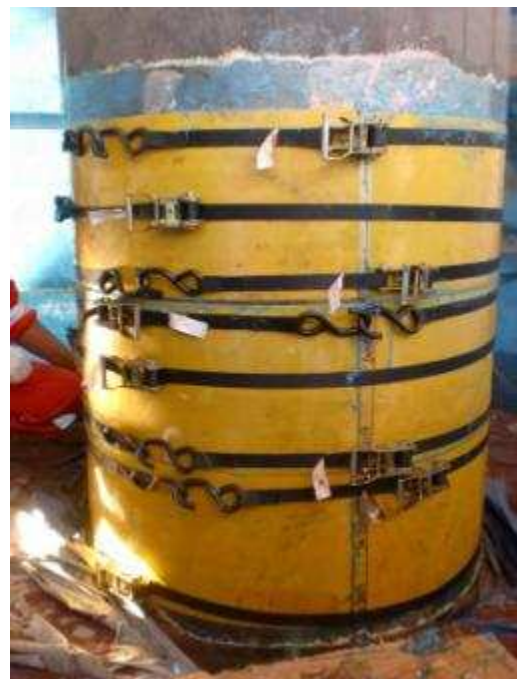
A 36" sump caisson was leaking in one of the offshore oil and gas platforms in Natuna Sea. Due to the allowable window of shutdown during the repair, a Snap Wrap was chosen to repair these sections and return the integrity of the caisson.

Figure 11. Sample of completed sump caisson repair

After surface preparation by sand blasting, the Snap Wrap was applied for one meter of total length to restore the capability of the operating caisson. The repair was made within two days with four (4) man crew only.

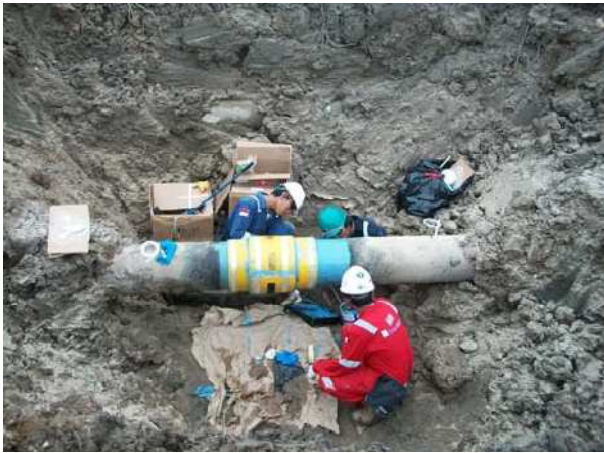
Significant external corrosion, up to 74% metal loss, adjacent to and affecting the circumferential girthweld was located within an onshore LPG Gas Terminal in Samarinda, Kalimantan.

Figure 12. Completed girth weld repair

A standard bridging technique for the full cured laminate repair sleeves was applied utilising 3 complete 8 layer repair kits to support and bridge over the girth weld.

The repair was installed by a two (2) man crew within 3 hours and with pipeline inoperation and no hot work.

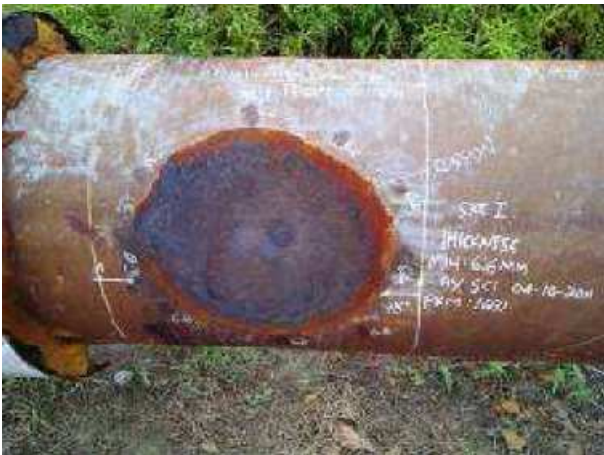
An external defect due to corrosion under insulation (CUI) and hot atmospheric conditions was found after Long Range UT testing was conducted on a main hot water injection line to the main oil wells in Duri.

Figure 13. Sample of the CUI defect

Following manual surface preparation in accordance to industry standard (NACE) guidelines, composite repair sleeves were applied to reinforce the corroded area.

In total 16 repair kits were installed by four (4) man crews within 3 days.

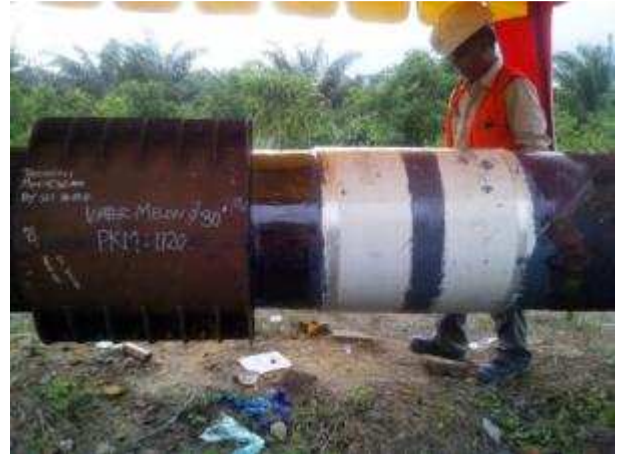
Figure 14. Completed high temp repair

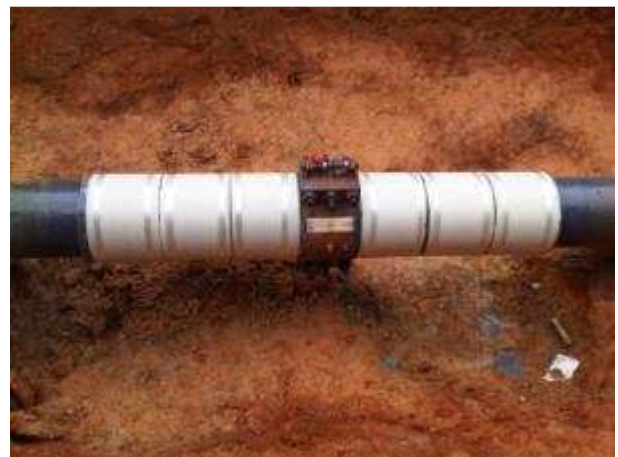
A 12" gas pipeline in South Sumatera was found to be cracked and leaking and in need of urgent repair. A composite repair sleeve was considered to provide structural integrity and to prevent a running fracture from the longitudinal crack within the maximum operating pressure of 1,200psi (83 bars).

Figure 15. Completed 12" Crack Arrestor repair

Due to the crack nature of the defect and to prevent expansion/bulging and failure of the pipe either side of the leak repair clamp it was recommended to install 1 meter either side of the clamp 12" Crack Arrestors.

This will not prevent the pipe from continuing to crack but if it does it will prevent rupture. It is very important this region of the pipe is restrained as it will greatly help the complete function of the total repair.

The installation was completed by a five (5) mancrew within 1 day.

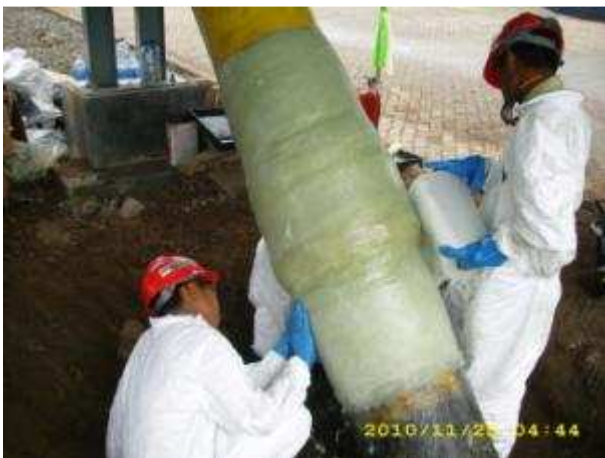
Major Gas Distribution Company operating in Surabaya, East Java was having a problem at their 16" gas pipeline due to ground movement and transferred load to the operating pipeline. The operator was worried an insulating joint at this location would potentially leak in the future due to the loads being transferred to the pipeline.

Figure 16. Contour – insulating joint repair

For this repair a wet applied composite fabric was utilised to provide structural integrity to the insulating joint location and to accommodate the complex geometry.

Following excavation and manual surface preparation in accordance to industry standard guidelines, the wet applied composite repair was applied with thickness and axial lengths to prevent potential leakage of the joint in the future. This repair was designed and applied in accordance to current industry guidelines.

The repair was completed under the supervision of a qualified installer within 2 days.
